Hurricane Irene and the Pea Island Breach: Pre-storm site characterization and storm surge estimation using geospatial technologies

Adam S. Clinch¹, Emily R. Russ², Ross C. Oliver¹, Helena Mitasova², and Margery F. Overton¹

ABSTRACT

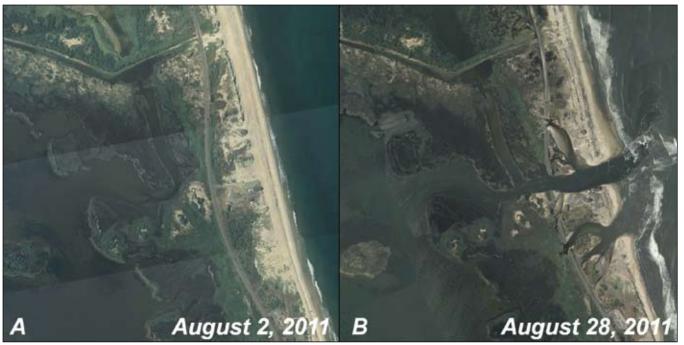
Figure 3. Pea Island breach site before and after Hurricane Irene. (A) was taken on 2 August 2011 before Hurricane Irene reached the Outer Banks on 27 August 2011. (B) was taken after Hurricane Irene on 28 August 2011 (NCDOT imagery).

Hurricane Irene, including breaching of the barrier island in two places: Pea Island and the north side of Rodanthe known as Mirlo Beach. Soon after the storm, the Rodanthe Breach closed naturally and the NCDOT repaired the dunes and the roadbed in the area. After the immediate post-storm monitoring of the breach at Pea Island, the NCDOT also acted to install a temporary bridge to restore the NC 12 transportation corridor.

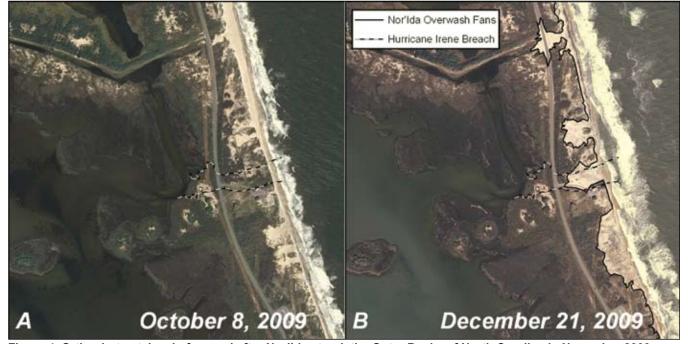
Figure 4. Orthophotos taken before and after Nor'lda struck the Outer Banks of North Carolina in November 2009. Figure 4A, on the left, was taken on 8 October 2009. Figure 4B, on the right, was taken on 21 December 2009.

In November 2009, Nor'Ida, which was a combination of Hurricane Ida and a nor'easter, brought offshore storm conditions to the Outer Banks. Nor'Ida produced storm waves (those defined as larger than 2 meters) for 99 hours at the USACE's Field Research Facility in Duck (USACE 2012). Figure 4 shows how the study area changed before and after Nor'Ida. Figure 4A, was taken on 8 October 2009 and Figure 4B was taken on 21 December 2009. In both figures, the location of the future Hurricane Irene breach is indicated by the dashed black and white line. Although some previous dune degradation can be seen in Figure 4A, Figure 4B shows a new overwash fan, situated directly where the breach later broke through in Hurricane Irene.

The position of the breach directly in the path of one of the overwash fans sug-

gests that weakening of the dune system from Nor'Ida may have contributed to the size and location of the Pea Island Breach. To visualize the extent of the damage, a cross section at the breach site was extracted from pre and post Nor'Ida LiDAR data. The pre-Nor'Ida DEM was created from LiDAR points collected in March 2008 as part of the Integrated Ocean and Coastal Mapping (IOCM) project conducted by the National Oceanic and Atmospheric Administration (NOAA). The post-Nor'Ida DEM was constructed using LiDAR points from the NASA/USGS Experimental Advanced Airborne Research LiDAR (EAARL) program (Hardin et al. 2012). This Li-DAR data was collected in December 2009 as a post storm reconnaissance for the Nor'Ida storm. Both dates of LiDAR data have a horizontal accuracy of two meters and a vertical accuracy of 0.15 meters. Using this data in GRASS GIS, a transect in the breach area was draped over the 2008 and the 2009 DEMs and the elevations were extracted and plotted to show the effects of the Nor'Ida event.

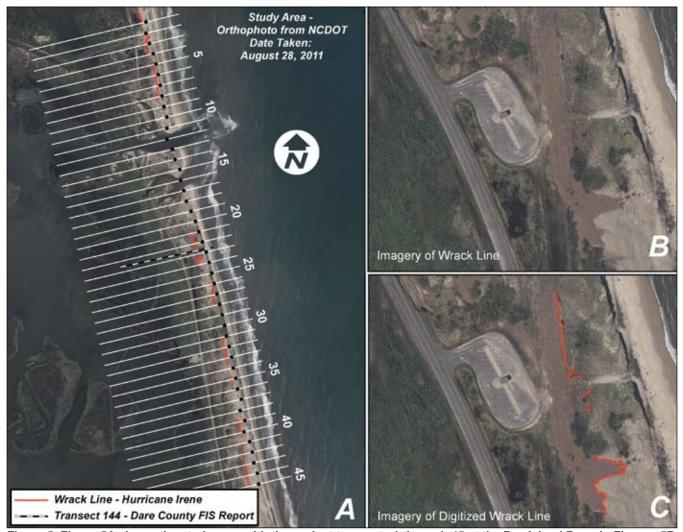
Figure 5. Figure 5A shows the study area with the project transects 1 through 45 at the Pea Island Breach. Figures 5B and 5C show a close view of the Hurricane Irene wrack line just south of the Pea Island Breach. The top-right image is without the digitized wrack line. The bottom-right image contains part of the digitized wrack line used in this study.

The wrack line digitized at the study site is presented in Figure 5A. Some of the fluctuation between wrack line elevations is apparent in Table 3. Note that since the vegetated debris is not a continuous line, not every transect has a representative wrack line elevation. Clearly for this case, the typical wrack line elevations shown in Table 3 exceed the maximum elevations for some transects in Table 2. The average elevation of nearly 1,300 digitized wrack line points was 2.57 meters (NAVD88) with a standard deviation of about 0.32 meters. Considering that the on-site investigations after Hurricane Emily produced standard deviations between 0.2 m and 0.7 m, the values determined using geospatial data seem relatively precise. Comparing data to a rapid deployment gage, the wrack line elevation analysis agrees to better than 0.3 m with direct measurements of water levels during Irene near the Rodanthe Breach (S. Rogers and A. Kennedy, pers. comm. 2012).

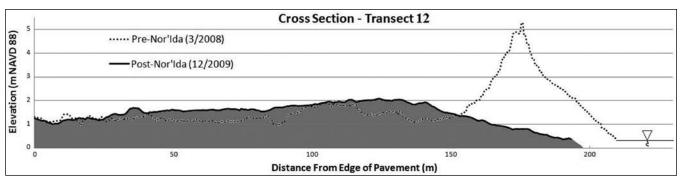
Figure 6. Pre-Nor'lda and post-Nor'lda profile at the Pea Island Breach, displayed from the edge of pavement to the oceanside mean high water level.

Investigation of the Pea Island Breach site conditions prior to the effects of Hurricane Irene has shown that the dunes in this area had been eroded due to the effects from Nor'Ida. At that time, the dune directly at the site of the breach was degraded, which clearly impacted the location of the breach. This was observed both in the pre and post-storm orthophotos as well as in the cross-section analysis at the breach site.

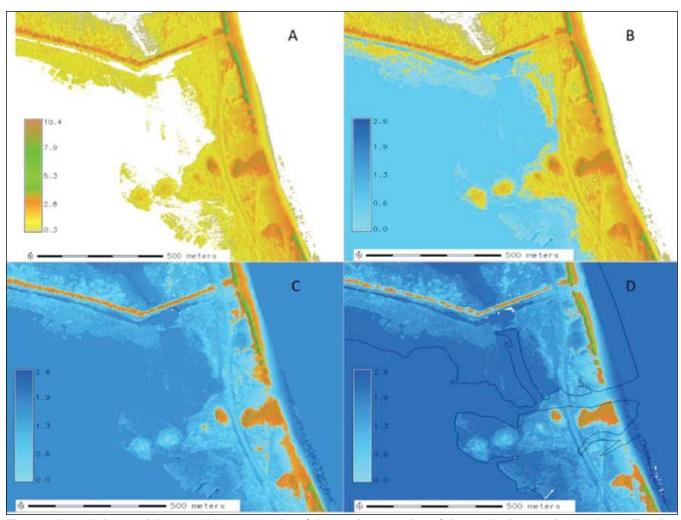
Figure 7. Inundation models over 2009 topography of the northern portion of the study site are shown above. Flood levels are given as (A) 0.3 m, (B) 1.0 m, (C) 2.1 m, and (D) 2.57 m NAVD 88. Topographic elevations are given in meters in map A. An outline of the post-Irene breach site is included in map D.

Figure 7 shows four stages of inundation (0.3 m, 1.0 m, 2.1 m, and 2.57 m NAVD88) on the breach region of the study site. The final inundation map of elevation of 2.57 m also shows the shore outline of the breach directly after the storm. When the Pea Island area is flooded to the average high water elevation determined from the wrack line analysis, the flooded area corresponds to

the location of the breach. Inundating the sound behind Pea Island to an elevation slightly smaller than the average wrack line (2.1 m) shows that flooding in this area occurred primarily at both channels first, before expanding and inundating surrounding areas. Figure 8 displays a three dimensional post-Irene orthogrametric image, inundated to the average wrack line elevation. Although the wrack line elevation represents wave setup and run-up in addition to surge, this figure gives a good representation of what areas of Pea Island were inundated at the highest water level of the storm.

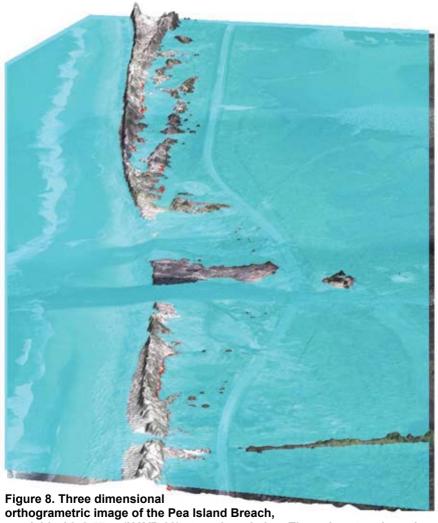
orthogrametric image of the Pea Island Breach, overlaid with 2.57 m (NAVD 88) storm inundation. The red vector along the heel of the dunes shows the digitized wrack line used in this study. dune ridge extraction due to the degraded dune at this site. Nevertheless, 2.1 m is still the lowest maximum elevation for the study site, and thus, vulnerable to inundation. The second lowest maximum elevation occurs at transect 16 (2.4 m NAVD88). This area is the site of the second, smaller channel of the breach, which has also shown evidence of dune overwash damage prior to the storm.
